**Supplemental Information & Instructions  
for  
TACHO REDUCTION GEARBOX  
MG T SERIES**

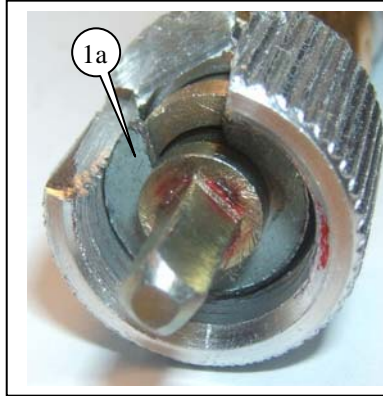
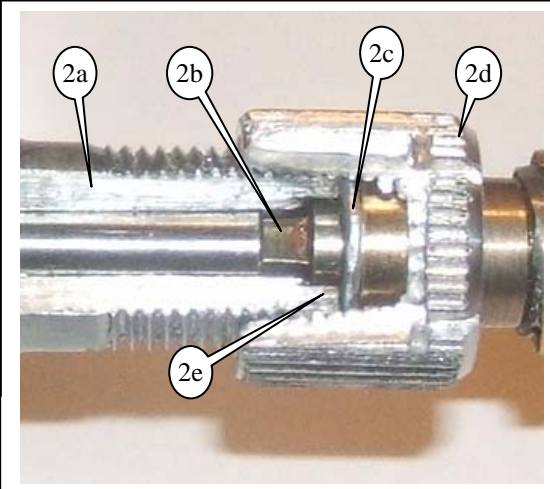
Found only with the OE style cable. The cable manufacturer currently uses a circlip (1a) to retain the inner cable in the housing. When attached to the tach reduction gearbox (2a), the circlip (2c) bottoms out against the end of the tach reduction gearbox (2e) when the nut on the cable (2d) is tightened. The cable is locked in place and it cannot rotate.
