R073E Repair Seal Kit

Our J826 MGA Side Curtains have been carefully designed and tested to insure an accurate fit and years of trouble free reliability.

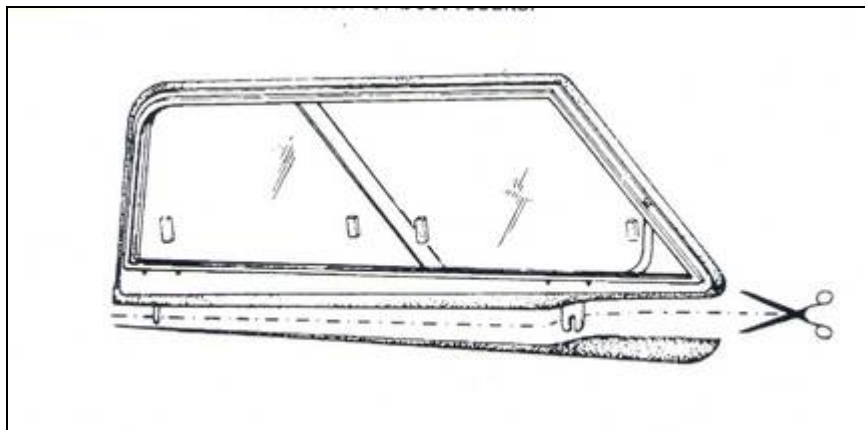
The lower rubber trim strip must be trimmed to fit your car. This is important as the front edge will foul the door jamb. (Refer to the drawing below and carefully mark the strip in pencil prior to cutting.) The intent is for the trim strip to nearly touch the painted surface of the door but not be trimmed so far as to expose the upholstered door top rail when viewed from the outside. The front edge that rests over the rear of the front fenders should be trimmed very short so that it does not rub on the paint. In some cases it may be necessary to file the aluminium strip that this seal attaches to.
